SITE ASSESSMENT/COST PROJECTION
FOR
DRISCOLL AND COMPANY, INC
CHICAGO, COOK COUNTY, ILLINOIS
TDD: T05-9108-009
PAN:EIL0750SAA

SEPTEMBER 24, 1991

Re: Driscoll and Company, Inc., Site, Chicago, Illinois
TDD# T05-9108-009

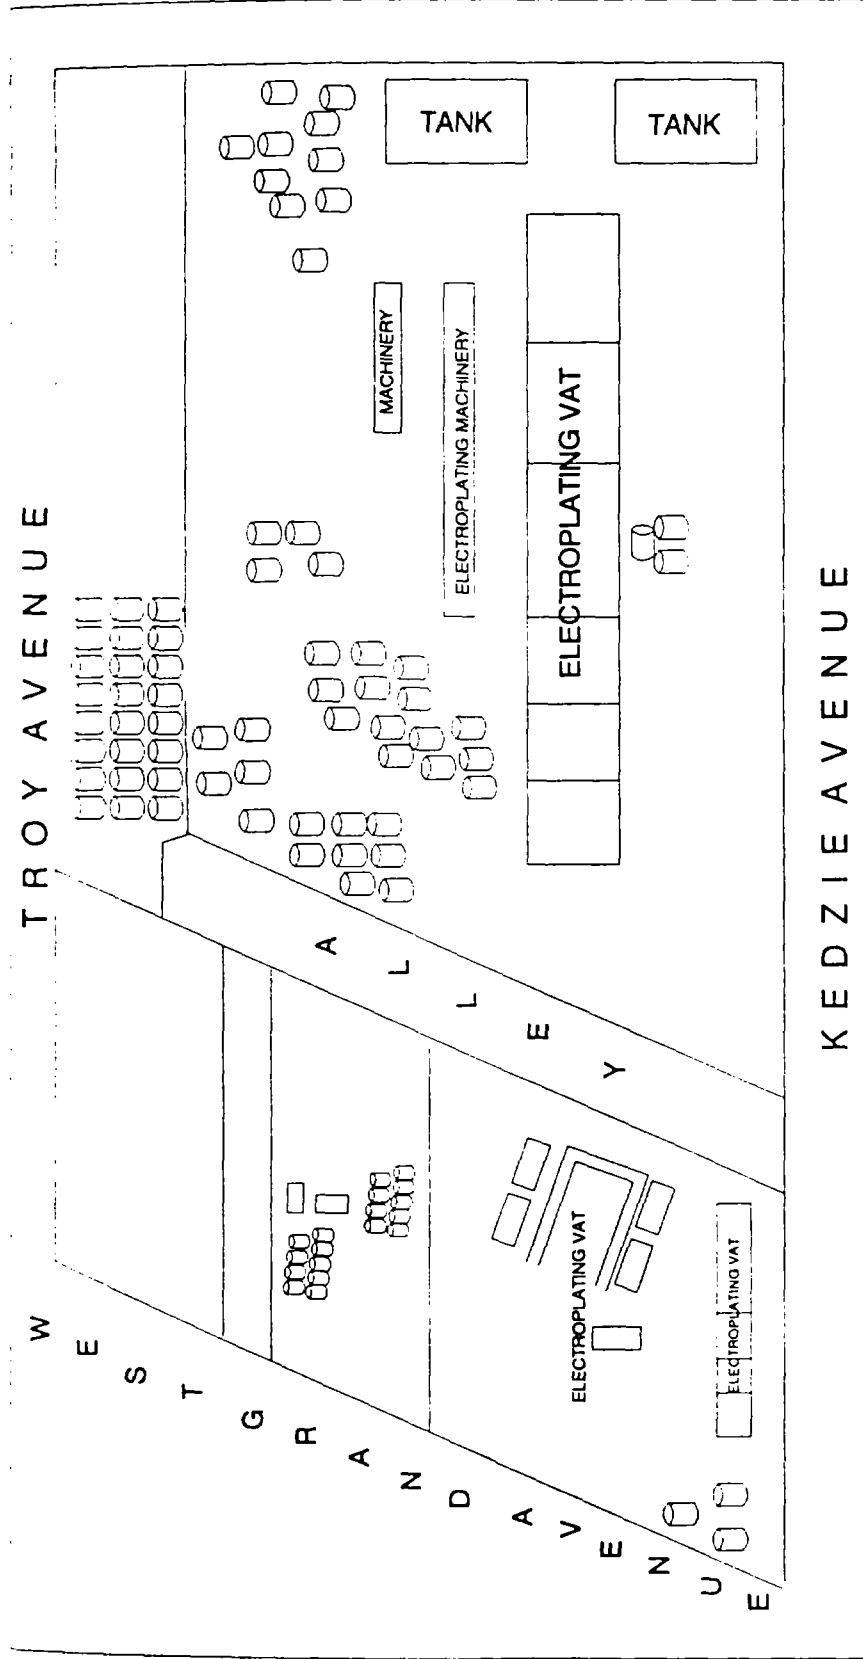
electroplating line is located in the middle of the southern building extending south from the alley. This plating line (vat) is divided into several compartments and contained dark green colored liquid (Refer to Figure #2 for site sketch). The volume of liquid contained in this vat is estimated to be 10,200 gallons. TAT collected a sample from this vat and also ran a HAZCAT test on this liquid. Results of the HAZCAT test indicated chromium concentrations in the range of 3000-4000 ppm. TAT also observed electroplating equipment located adjacent to the electroplating line. This electroplating line appeared to be in a very deteriorated condition. Two metal tanks are located adjacent to the southern wall. The first tank contained debris and other material while the second tank contained approximately 3000 gallons of green colored liquid/sludge. To the east of this tank were several drums in poor condition with no labels on them. TAT observed an open yellow poly drum containing several bottles of laboratory chemicals. Some of these chemical bottles were labelled with EDTA, HCl, Bromine water, Monochromic acid, Nickel sulfite and Barium chloride. Located to the north of the electroplating line are several poly and metal drums. Some of these drums are identified as as containing hypochlorite, caustic and nickel solutions. Several blue poly drums with the label "Super Max" on them were also observed. The eastern wall of this building consists of a garage door with several metal drums stored in piles behind the door. A total of approximately 146 drums are estimated to be present in this building. The ceiling of this building in several places appeared to have cracked and leaked water. The ceiling is in a deteriorated condition with several white pieces of unknown, possibly asbestos-type material having fallen to the ground. A total of 10,700 gallons of liquid is estimated to be present in the tanks and vats within this building.

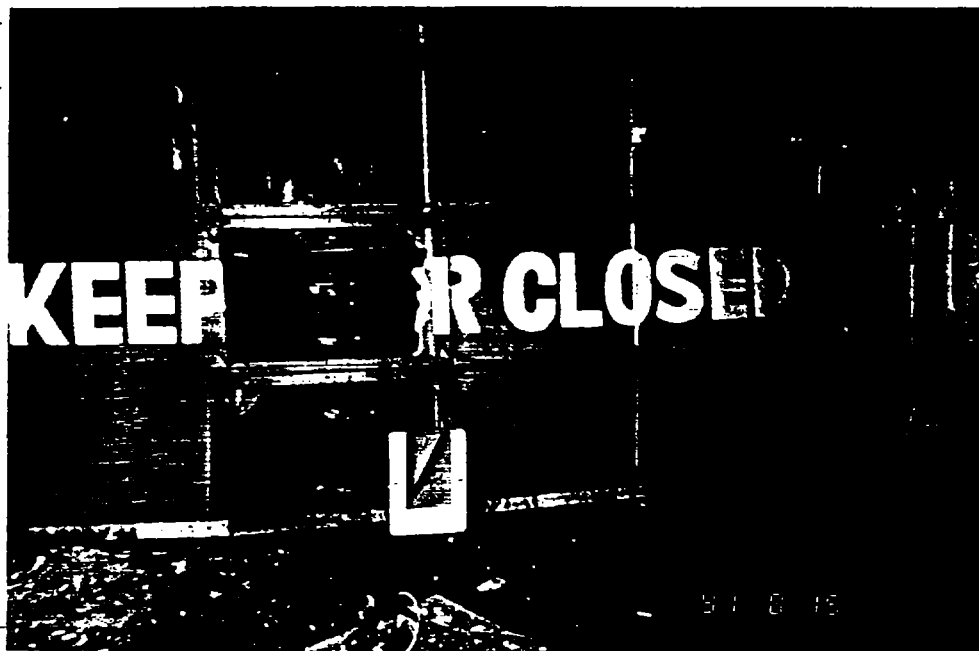
DESCRIPTION: Stacked drums behind the garage door

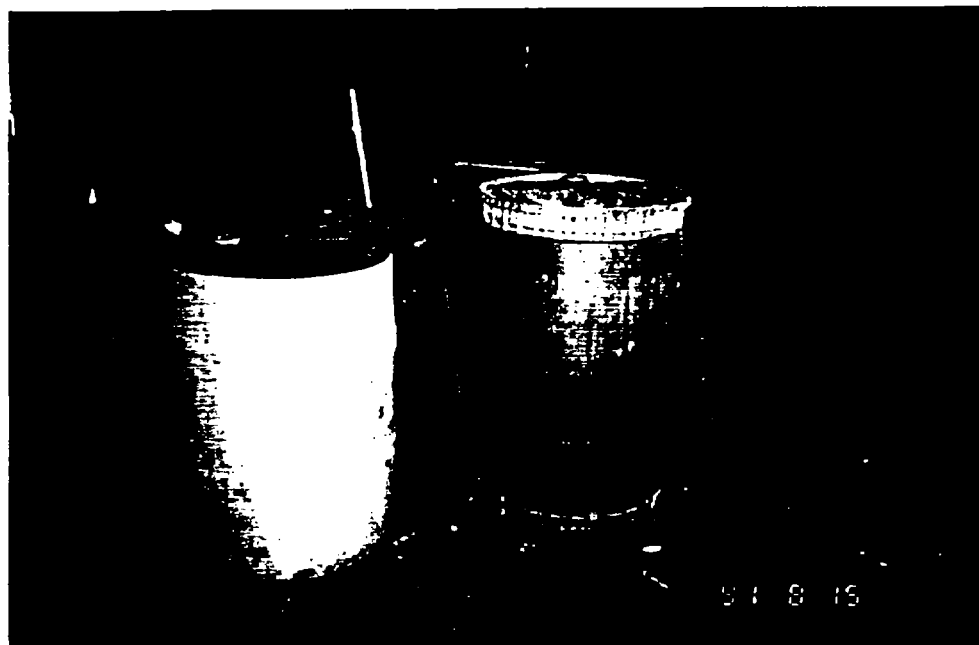
DESCRIPTION: Drum writings indicating possible trespassing

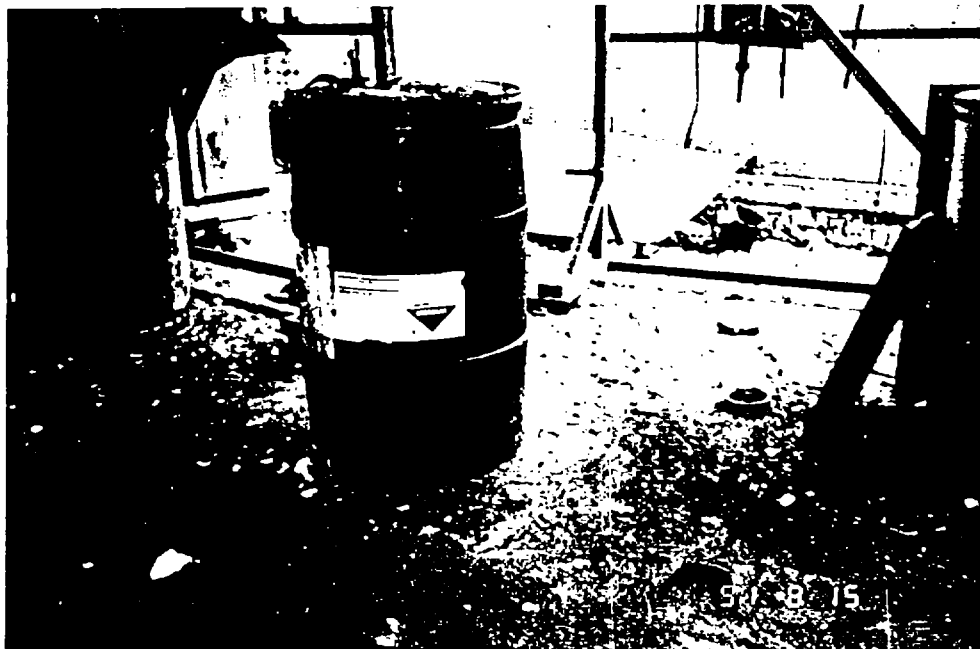
DESCRIPTION: Drum with sodium hypochlorite label on it

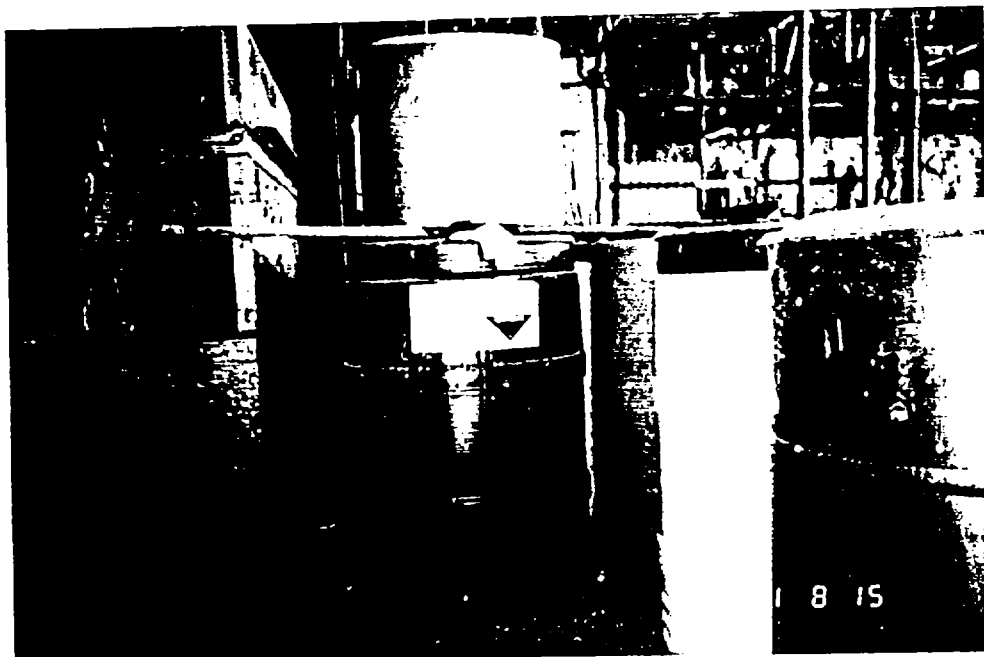
DESCRIPTION: Drum with caustic soda label on it. Sample D4 was collected from this drum

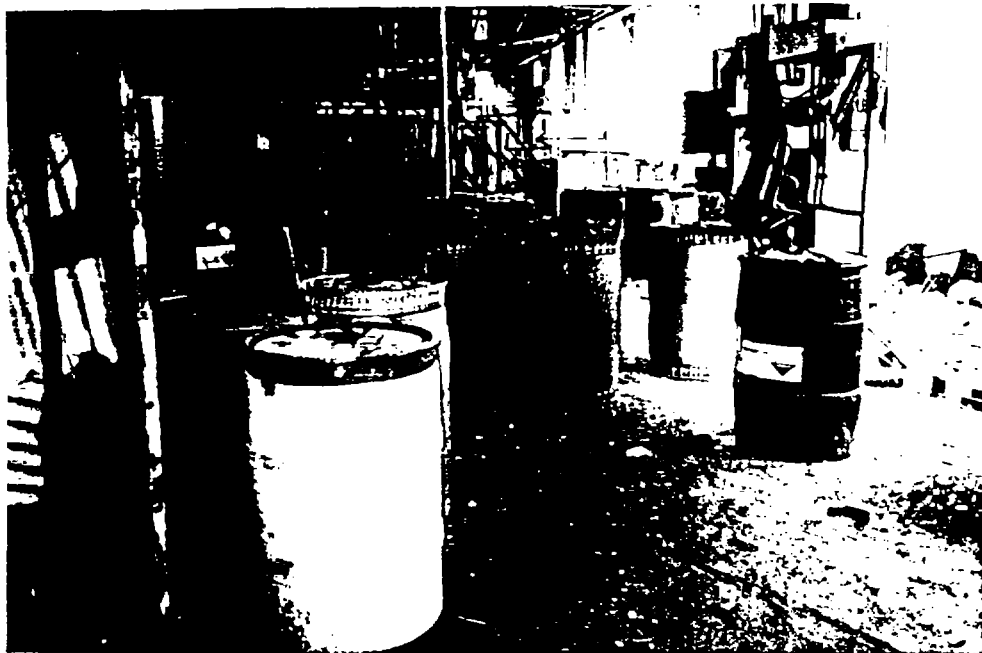
DESCRIPTION: Drums staged near the electroplating line

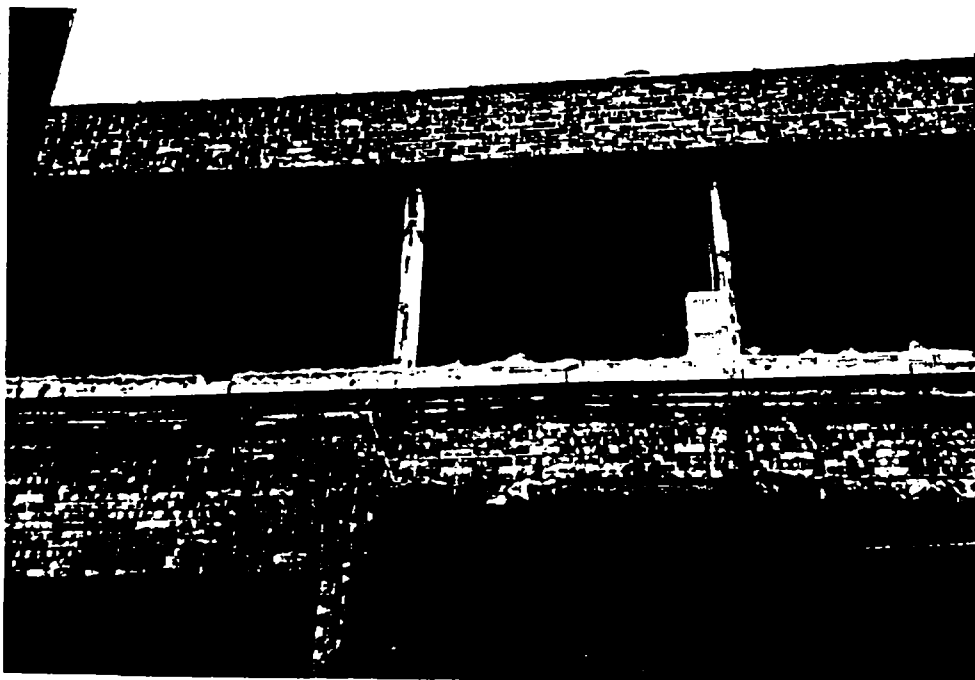
DESCRIPTION: Second floor of the northern building with broken windows

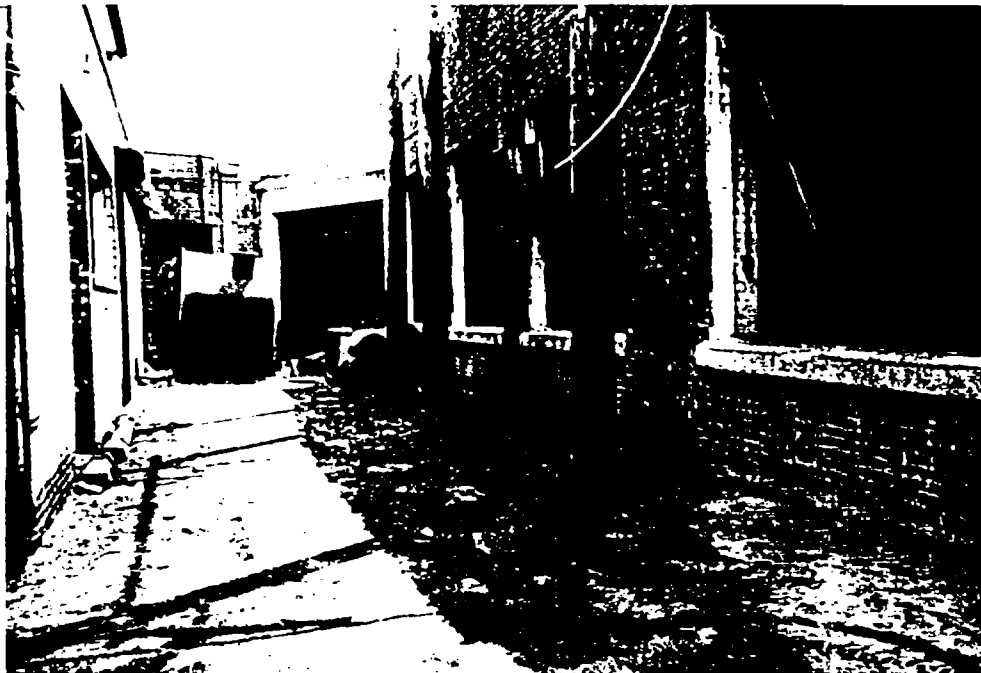
The alley between the two buildings opens out through an entrance on Kedzie Avenue. The alley contains some drums stored in stacks and two electric poles. The soil in the alley was dark-stained in color. An entrance from this alley leads into the northern building.

DESCRIPTION: Stained soil in the alley between the two buildings. In the background are some drums stacked in the alley

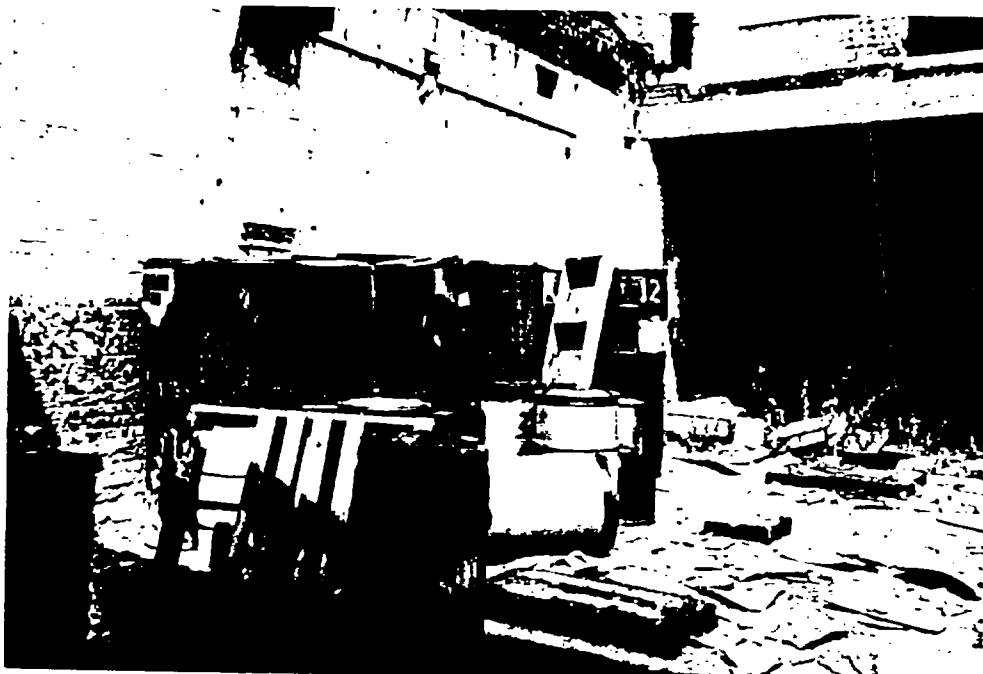
DESCRIPTION: Empty drums stored in the unroofed area of the northern building

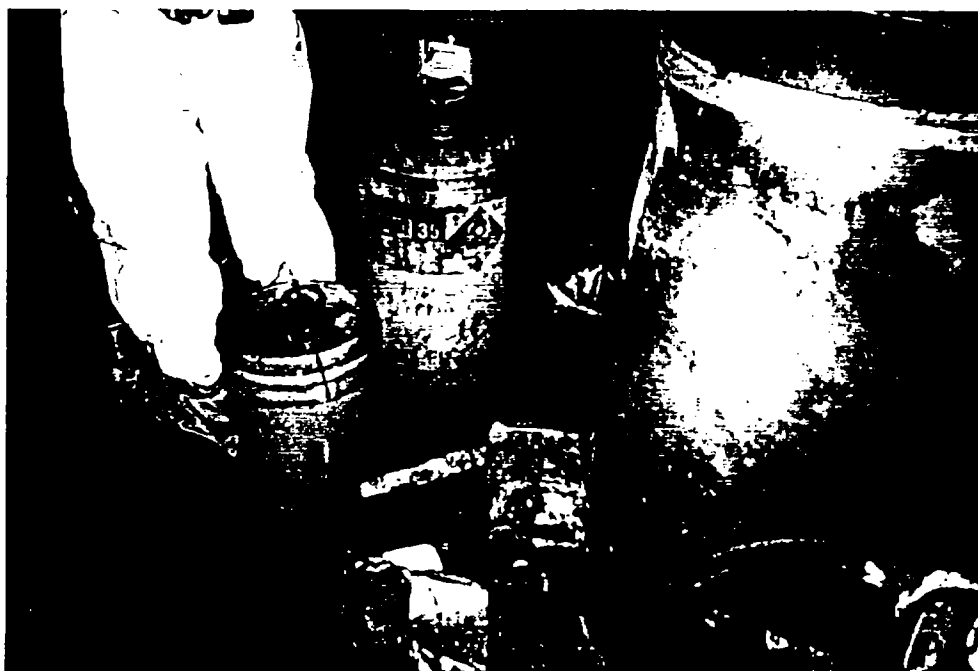
DESCRIPTION: View of several containers near the electroplating line in the
northern building. The white container has hydrogen peroxide label on it

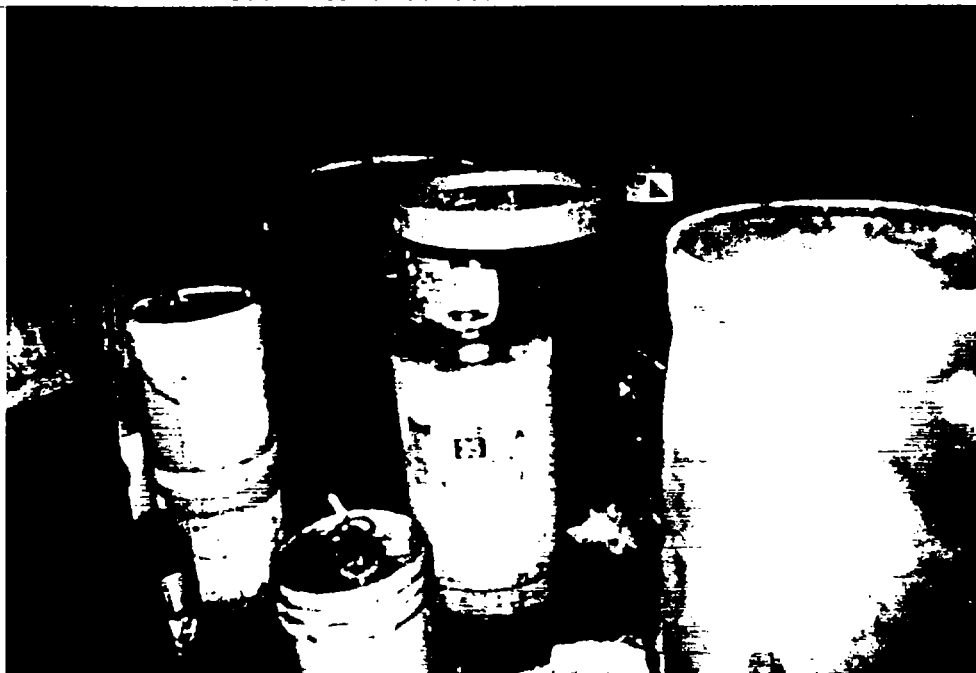
DESCRIPTION: View of the yellow bordered drum labeled sulfuric acid in the back ground. In the front is the hydrogen peroxide drum
